Manhole Inspection Summary

Manhole # S47G2_008MH

Insp Date: **1/16/08 10:20 AM**

Location Address: **1640 Hazel St**

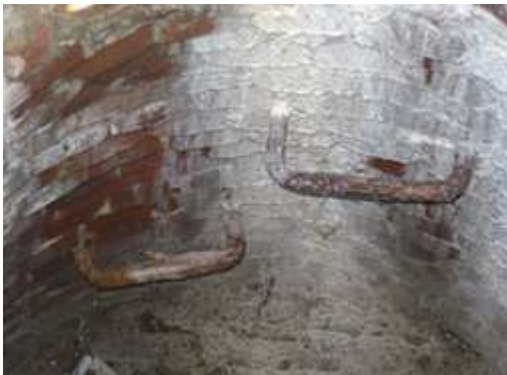
Steps Count: **2** Missing: **0** ☐ Corroded

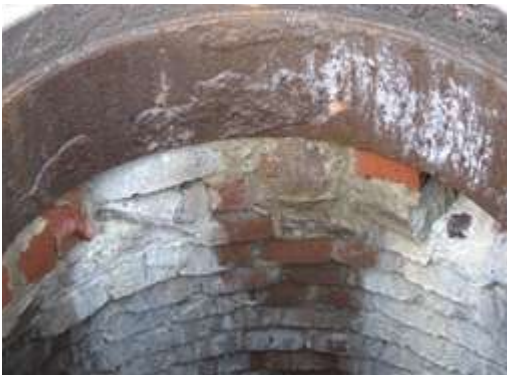
Defect 1

Condition: ☐ Sound ☐ Cracked ☐ Root Intrusion ☒ **Loose Brick** ☐ Deteriorated

Infiltration: ☐ None ☐ Joint ☐ Cracks ☐ Mortar ☐ Roots ☒ **Wall**

Chimney

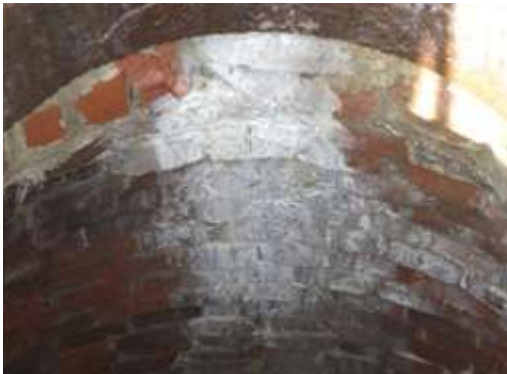
Defect 2

Infiltration: ☐ None ☐ Joint ☐ Cracks ☐ Mortar ☐ Roots ☒ **Wall**

Wall

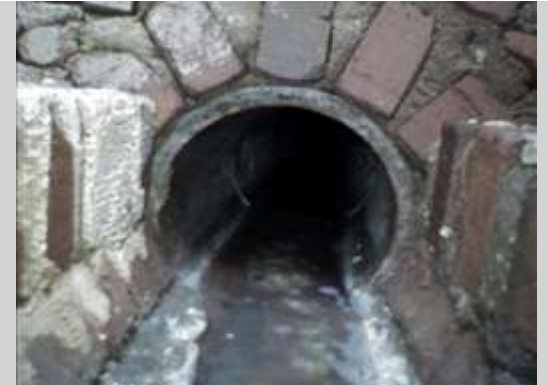
12 O'Clock Outflow

8 in. Circular Gravity Sewer
Pipe Out @ 12 O'Clock

Pipe Height: **10.8** (in.) Rod and Bar (Angled)
Pipe Material: **Clay** ☐ Pipe Lined
Invert Depth: **6.29** (ft.) Flow Characteristics: **Fast**
Deposits: ☒ None ☐ Mud ☐ Sludge ☐ Debris ☐ Grease
Silt Depth: (in.) Deposits Extent:
Infiltration: **None** Pipe Seal Cond: **Sound**

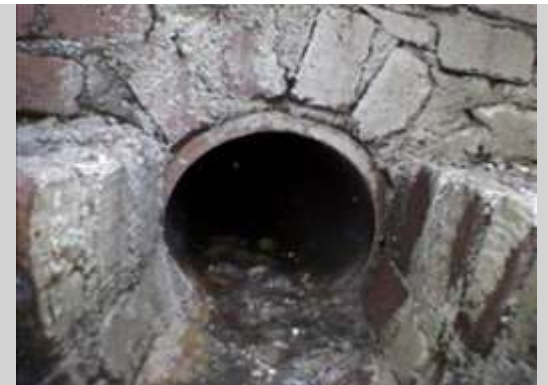
3 O'Clock Inflow

8 in. Circular Gravity Sewer
Pipe In @ 3 O'Clock

Pipe Height: **9.6** (in.) Rod and Bar (Angled)
Pipe Material: **Clay** ☐ Pipe Lined
Invert Depth: **6.11** (ft.) Flow Characteristics: **None**
Deposits: ☒ None ☐ Mud ☐ Sludge ☐ Debris ☐ Grease
Silt Depth: (in.) Deposits Extent:
Infiltration: **None** Pipe Seal Cond: **Sound**

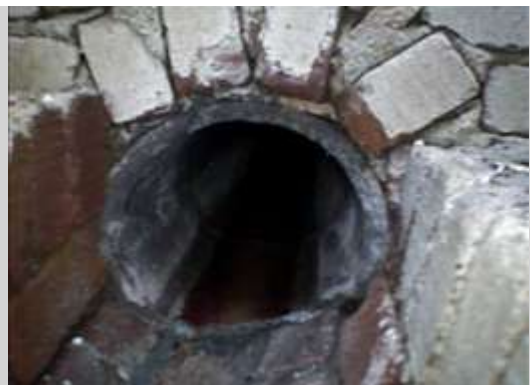
6 O'Clock Inflow

8 in. Circular Gravity Sewer
Pipe In @ 6 O'Clock

Pipe Height: **9.6** (in.) Rod and Bar (Angled)

Invert Depth: **6.19** (ft.) Flow Characteristics: **Fast**

Infiltration: **None** Pipe Seal Cond: **Sound**
